> August 27, 2015 60309393

Subject: Winston Trails East Community Development District - Annual Inspection Report

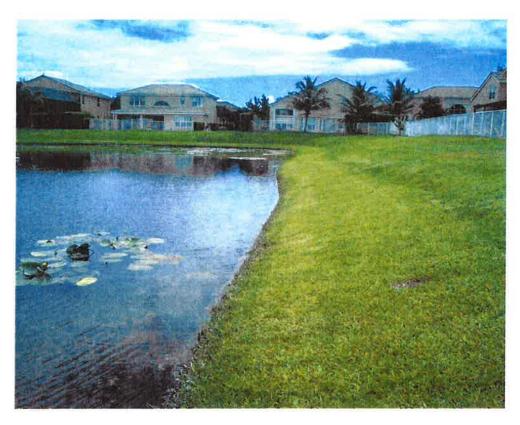
- Stabilization of lake bank erosion As reported in last year's report, it is apparent that a
 majority of the lake's banks have experienced erosion, leaving some with drop offs of over 2
 feet. We observed erosion control measures currently being installed on Lake 3 (see Figures
 6-9, 11).
- 2. Implement a quarterly maintenance schedule for the storm water control structures and vegetation control around culvert connections within all lakes.
- 3. If the inlets throughout the development have never been cleaned out, it is recommended that WTECDD contract with a company to clean out accumulated sediments. This could be done a rotating basis. The inlets were clear of trash.

Figure 6 – South End of Lake 3 West of Shadow Creek Village Circle Looking East on 05/29/2015 - Erosion Protection has been completed.

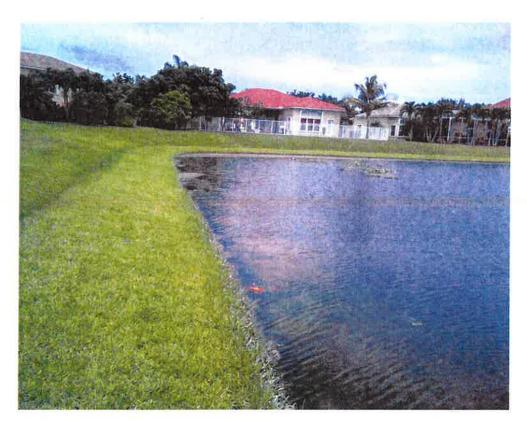
Figure 7 – South End of Lake 3 North of Shadow Creek Village Circle Looking Northeast on 05/29/2015 – Erosion Protection has been completed.

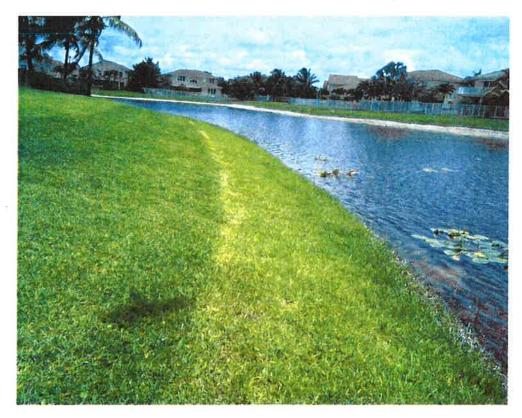
Figure 8 – South End of Lake 3 North of Shadow Creek Village Circle Looking Southeast on 05/29/2015 – Erosion protection has been completed.

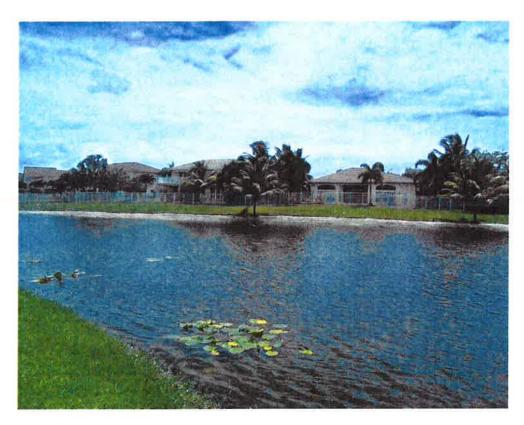
Figure 9 – East End of Lake 3 East of Indianwood Village Lane Looking West on 05/29/2015 – Erosion protection installation on opposite bank ongoing.

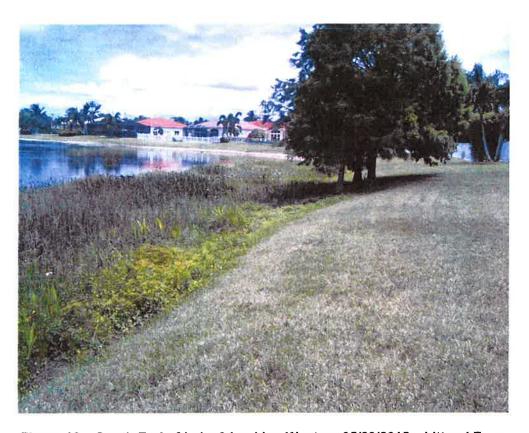
Figure 10 – South End of Lake 3 Looking West on 05/29/2015 – Littoral Zone

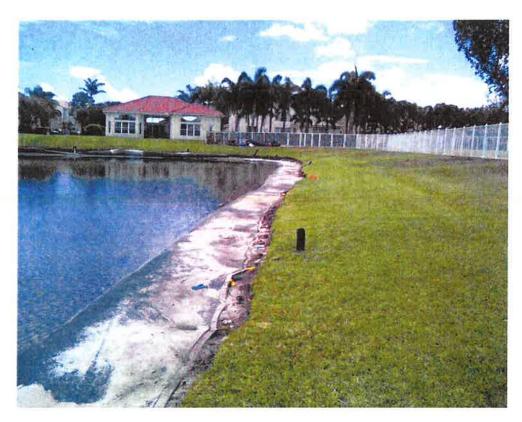
Figure 11 – South End of Lake 3 Looking East on 05/29/2015 – Erosion protection in process of being installed.
